CONSTRUCTION CLUES

THE ARCHITECTURE OF PORTENCROSS CASTLE

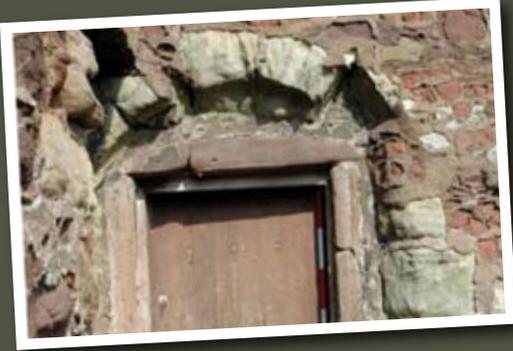
Robert the Bruce gave the lands of Arnele to Robert Boyd of Kilmarnock in 1315. The Boyd family built the castle in the mid 1300s. The rectangular 'hall house' was converted to a 'tower house' over time. Portencross Castle is both a scheduled ancient monument and a grade 'A' listed building. It boasts a vaulted great hall, which is rare in a Scottish hall house.

There have been three main phases of construction through successive generations of the Boyd family. In more recent times, the castle has been maintained as a monument.

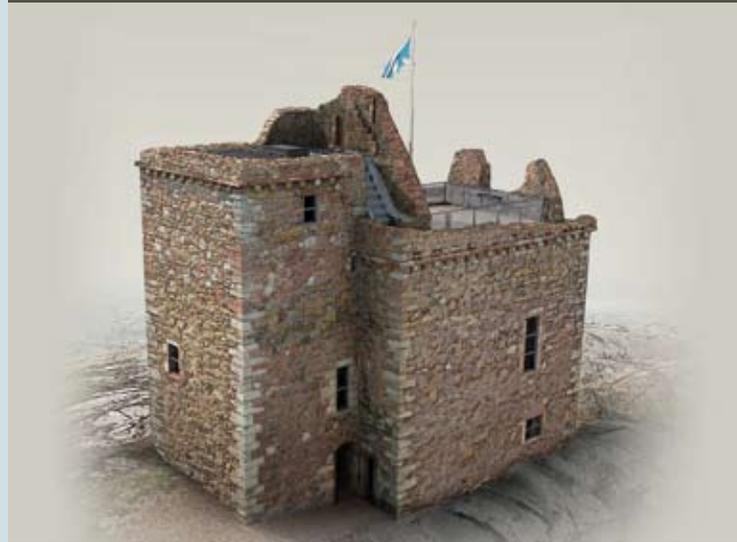
Portencross Castle from the east (MacGibbon & Ross 1889)

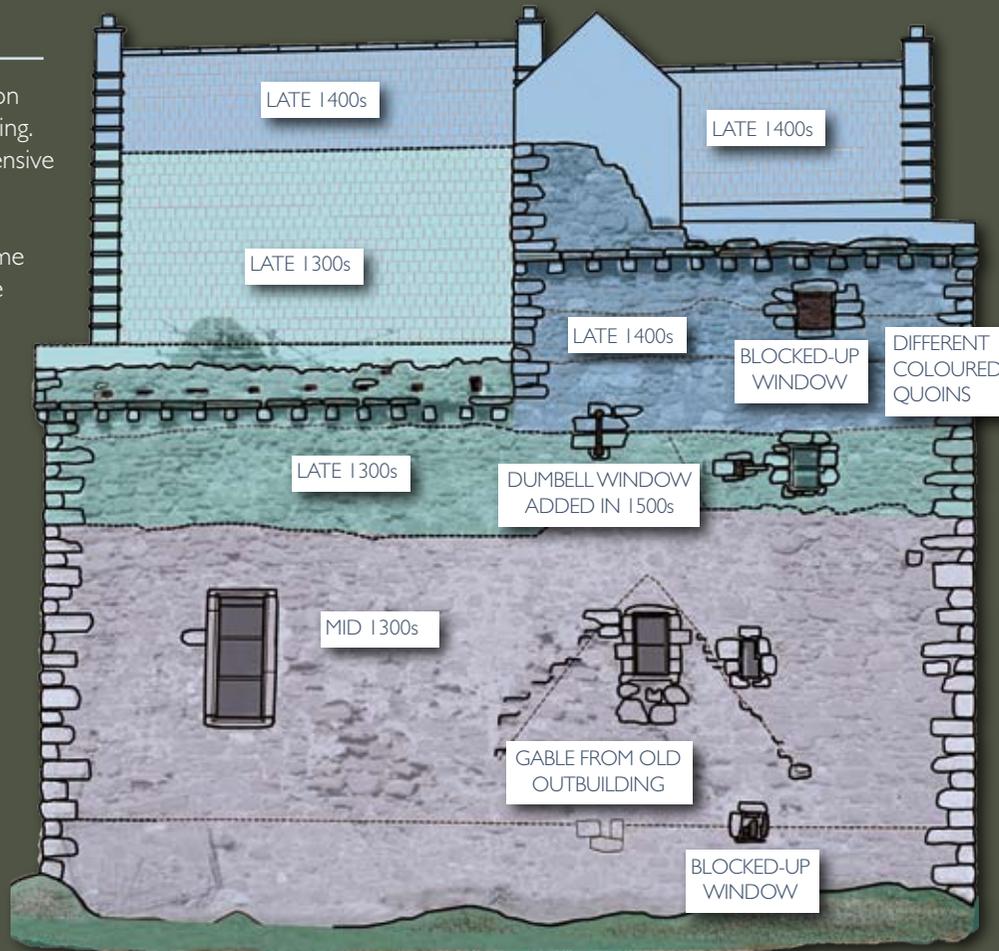
The original hall house the possible barmkin and lower wing

The first phase of building was the construction of the hall-house - the lower part of the building. There may also have been a 'barmkin' or defensive wall, outside the castle.

The accepted view is that the east and west wings were not built at the same time, although there was probably a lower east wing which would have been for defence. This would make it one of only two castles like this in Scotland (the other being Whittinghame in East Lothian). So Portencross Castle was built as a traditional 'hall house' (phase I) and was converted over time into a tower house.

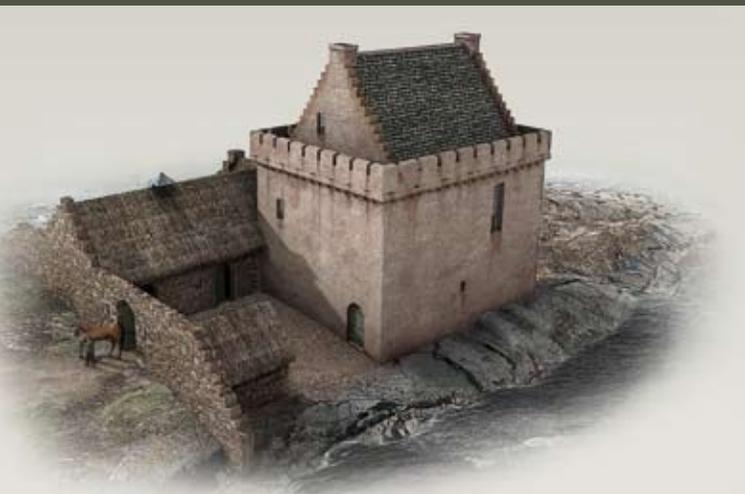
Original watercolour by Derek McLean, February 2010

If you look carefully, you can trace the original upper line of the house above the great hall and see where the next phase of building began. The drawing above shows each phase of the castle as seen from the south-west side. As you walk round the building, notice that the corner stones on the upper level are slightly different and must have come from a different part of the quarry or some other source. Much of the stonework would have been taken from the immediate area around the castle. As the height of the hall house was raised, the vaulted ceiling of the great hall was constructed, possibly with a chamber above. The battlements were also raised and altered. The windows were probably enlarged, the stairs steepened and a ground floor doorway added.
