PORTENCROSS CASTLE:
STANDING BUILDING SURVEY
AND WATCHING BRIEF

PROJECT 2597

carried out
on behalf of
Friends of Portencross Castle

GUARD
Glasgow University Archaeological Research Division

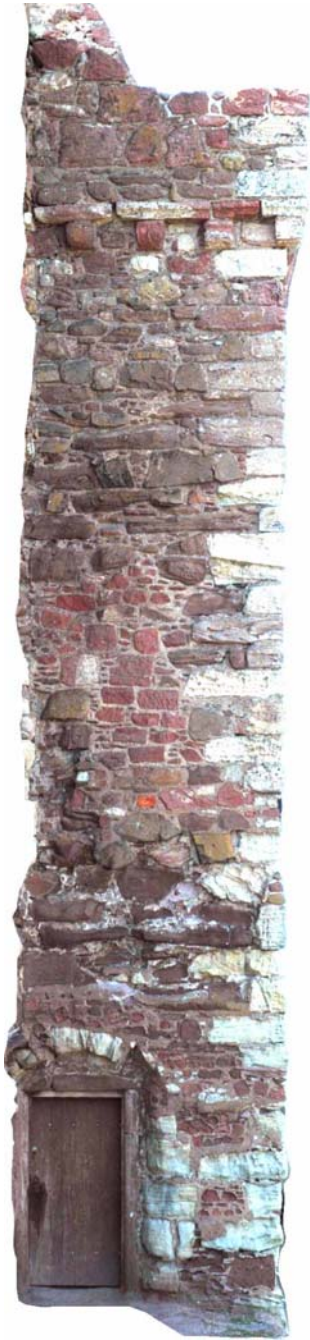
*Plate 8:
Ground floor doorway DG-1.*

Elevation 13 is the east elevation of the west wing (Plate 7). At ground level there is a doorway (DG-1) which has an arch and side jambs of blond sandstone which are very worn (129, Plate 8). Within this arch the side jambs of the doorway are of single red sandstones (128). The right hand jamb has cracked. Infilling the space between the jamb and the arch are small stones (130). The wall surrounding the doorway has been repaired with small red sandstones blocks (021). The corner quoins are of blond sandstone (002). Above this the wall is constructed of purple sandstone (022).

Architectural dating evidence for the construction of Portencross Castle is not abundant. The ground floor doorway (DG-1) is a segmented arch, very worn and has signs of repair. This could be in its original position, or could have been moved from a first floor position. It has been compared with the doorway at Cawdor Castle which is thought to be early-14th century in date (Caldwell *et al* 1998). The presence of the small pinning stones surrounding the doorway DG-1 is not necessarily evidence for the doorway being inserted, as this could be repair to the eroded face of the surrounded stones. However, the square doorway within this arch has been inserted.

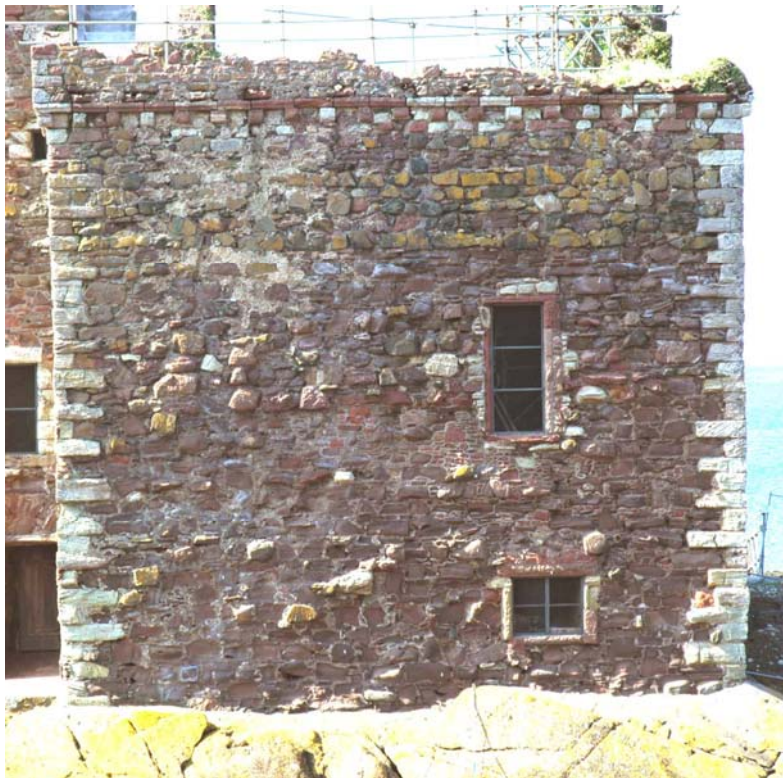
*Plate 9:
Elevation 1, north-east facing.*

Elevation 1 is the north-east facing elevation of the west wing. The majority of this wall is constructed of purplish-red sandstone blocks with a brown shelly mortar (001) with blond sandstone quoins (002, 003). On the ground floor there is a large rectangular window (WG-3) into the cellar (RG-2) with haphazardly built sandstone jambs, lintels and sill (Plate 10). To the E of this is a blocked window (WG-4) with the remains of a blond sandstone surround (Plate 11). A large rectangular window (W1-7) opens into the first-floor Great Hall (R1-2). This window surrounds are of worn red sandstone which has been repaired with modern sandstone on the west side (Plate 12). The window is surrounded by smaller stones (005) suggesting that it has been inserted or enlarged. There is a large patch of small pinning stones probably forming a repair (004) within wall 001.

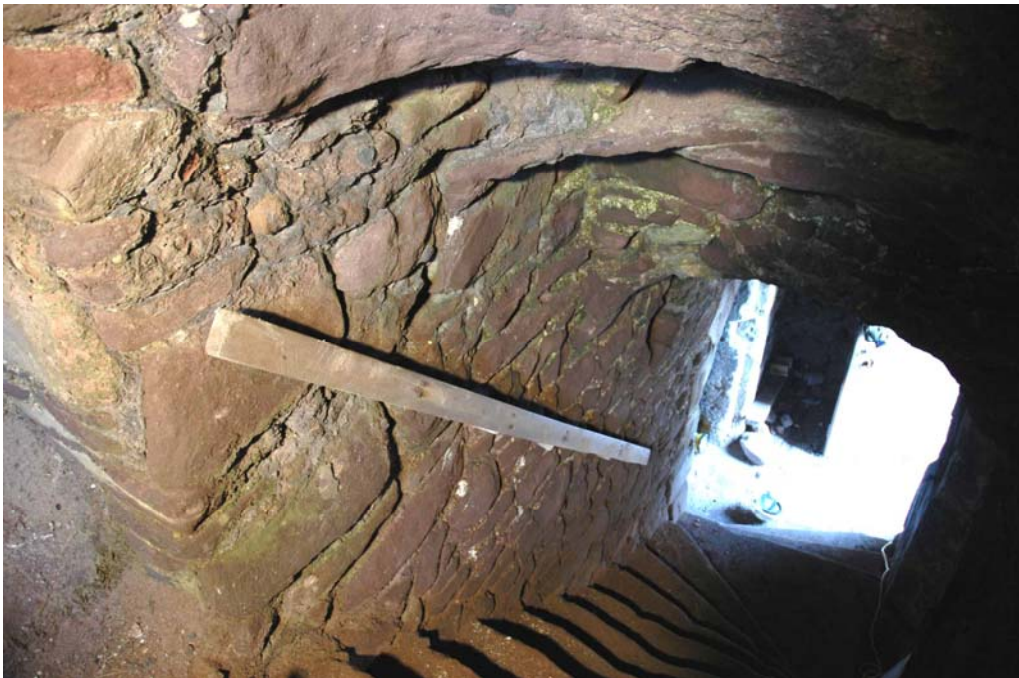
Plate 44:

Stairs (100) with roof cut back to provide extra headroom.

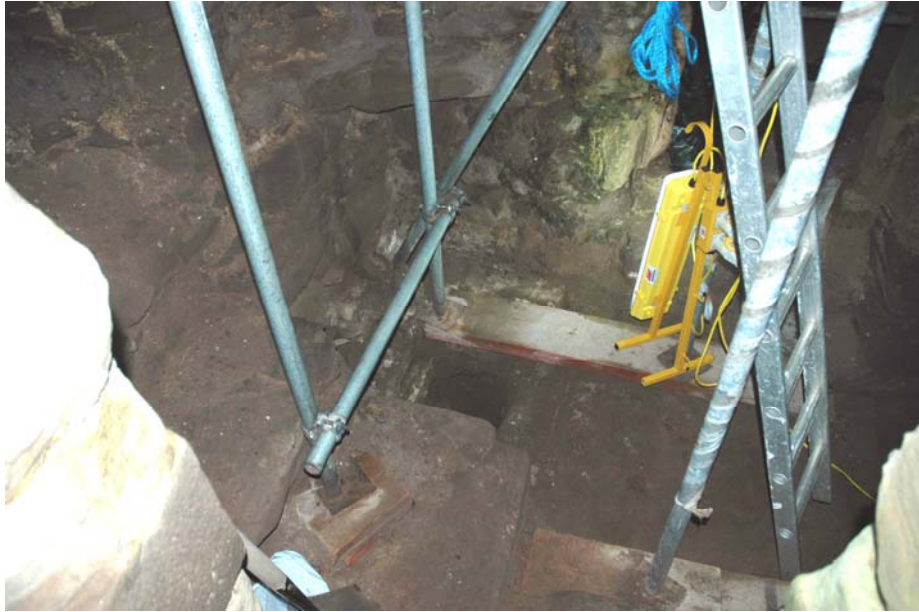
*Plate 45:
Entrance to the pit prison from the bottom of the spiral stairs.*

When loose debris was removed from the base of the spiral stair, the entrance to the pit prison was revealed (631). This was a rectangular hole, about 0.5 m wide, in the floor of the spiral stair with a sandstone surround which was very worn on the north-eastern side (Plate 71). A decision was made by the FoPC to cover this feature over again.

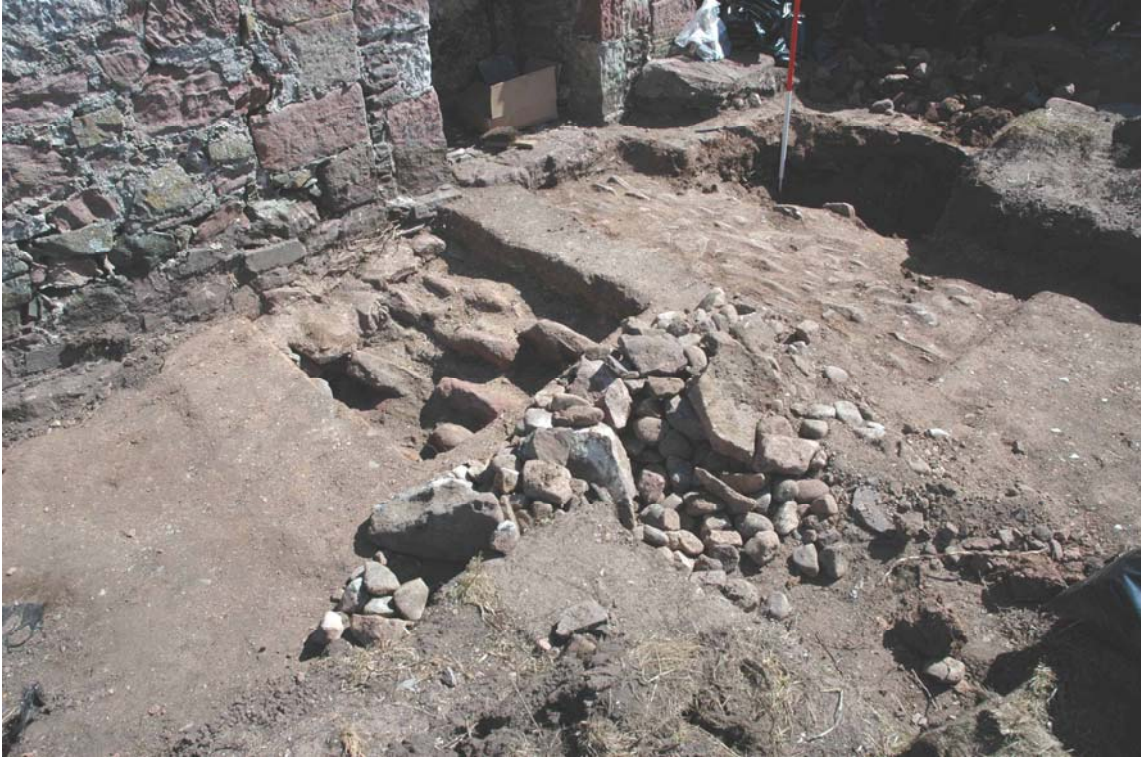
*Plate 62:
Lower Roof with the top of the vault revealed in part.*

The Lower Roof deposits were removed down to the top of the Great Hall vault in order to lay a new waterproof concrete screed. This revealed that the vault was sealed by vacuous beach pebbles (640) and a layer of compact mortar (639) (Plate 62). Above this was a layer of orange brown clay (638) which also contained fragments of roof slates, mammal bones and charcoal (Appendix 12.3). Above this were several broken roof slates (637) which were sealed by topsoil (636).

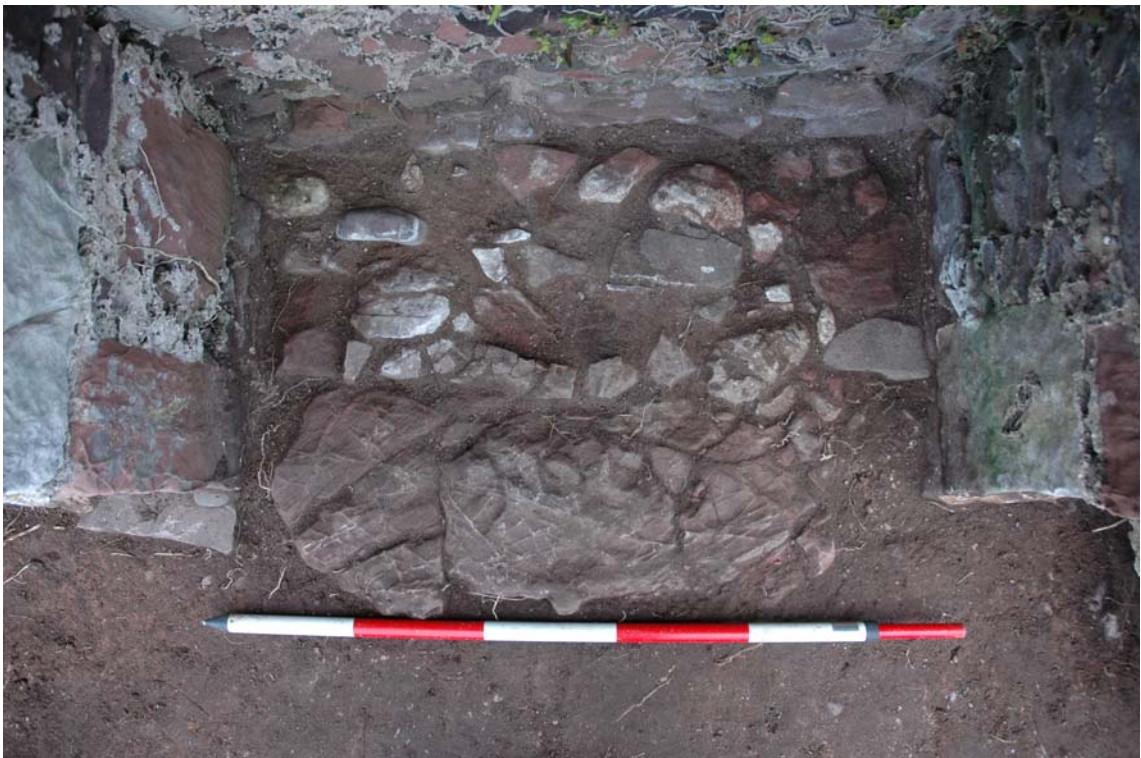
*Plate 63:
Base of Fireplace FP-4.*

The debris from the fireplace FP4 was cleaned out and an informal base was revealed consisting of one large fire-cracked stone at the front and smaller stones behind (Plate 63). To the right of fireplace FP-2 was a large stone within the topsoil (635) with a square recess cut into its surface, presumably to support a timber post (Plate 64). This stone was a re-used saddle stone from the parapet walk just to the west (pers comm David Turner).

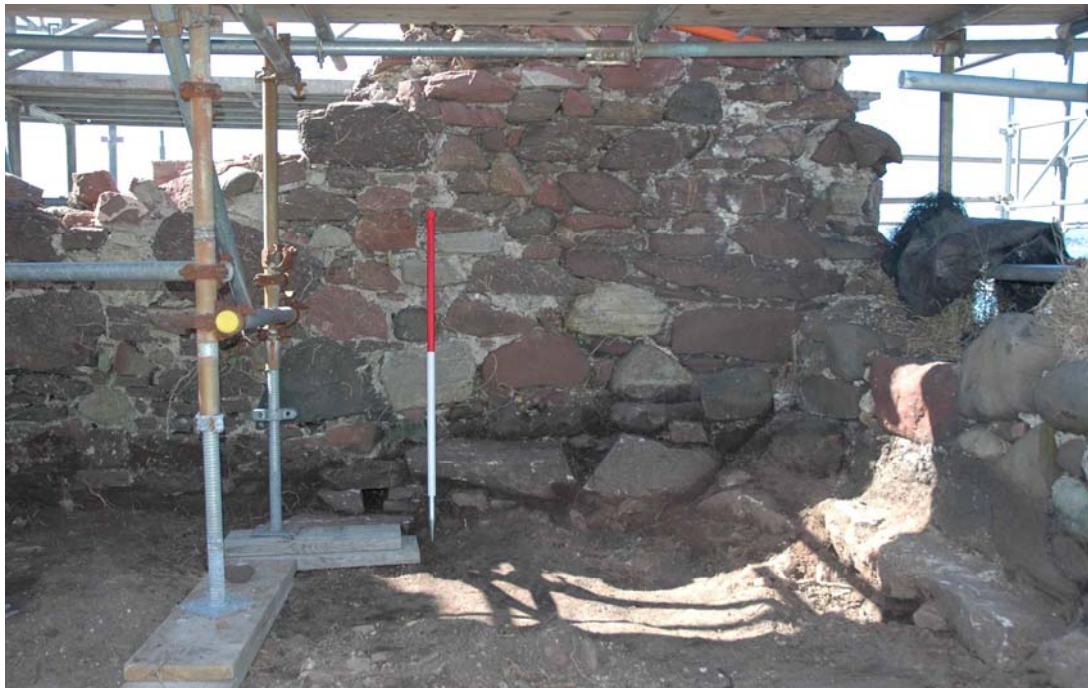
*Plate 65:
Interior of north corner of Lower Roof
showing the drain (630) to the left of the pole and the scarcement to the right.*

The north-west gable was cleared of vegetation and loose debris (Plates 65 and 66). On the inside the openings to the two drains (630) (Figure 10) were excavated and found to contain only loose modern debris. On the outside of the gable, the stumps of several broken saddle and trough stones could be seen, however there was a gap of about 3.7 m which corresponded with the location of the window (W3-3) and the two drains (630). This suggested that there was no parapet walk in front of the window.

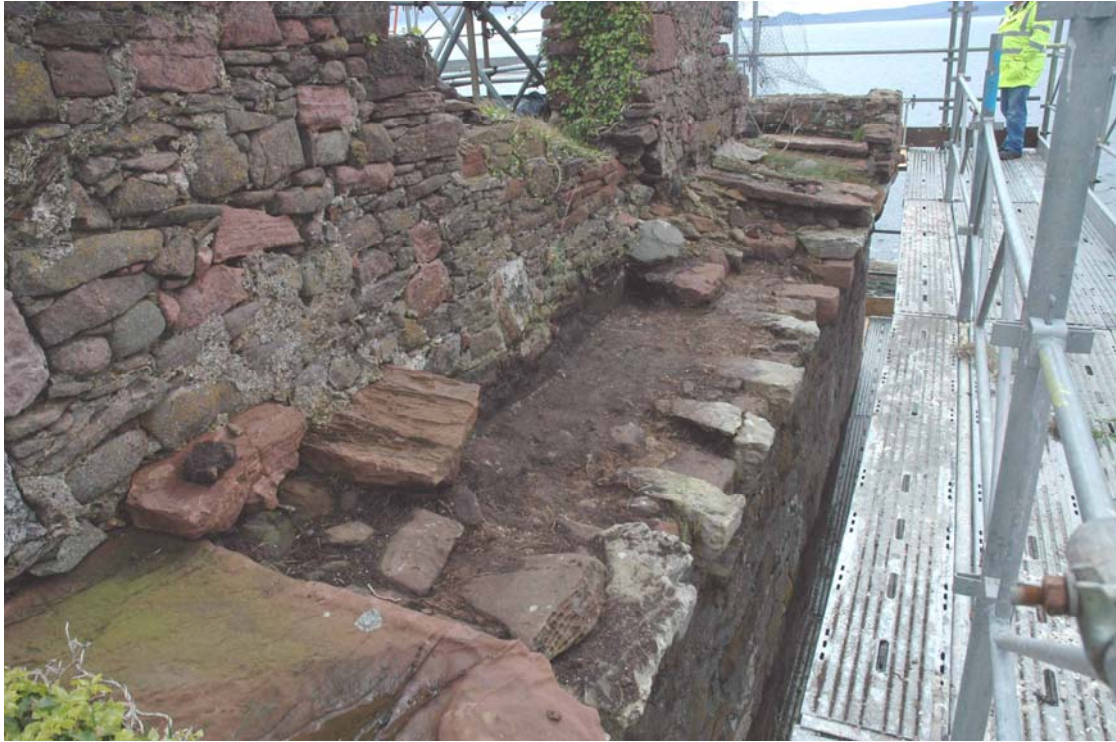
Plate 66:

Exterior of north-west gable. Note the broken saddle & trough stones on left and gap beneath the window.

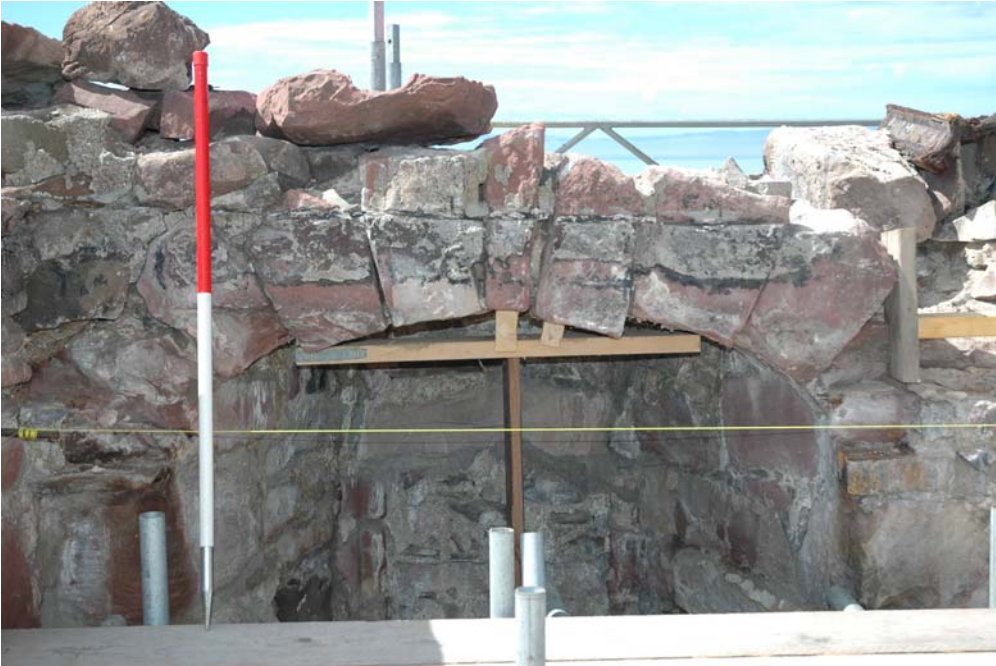
Plate 68:

Window W3-2 after the concrete roof removed from in front of it.

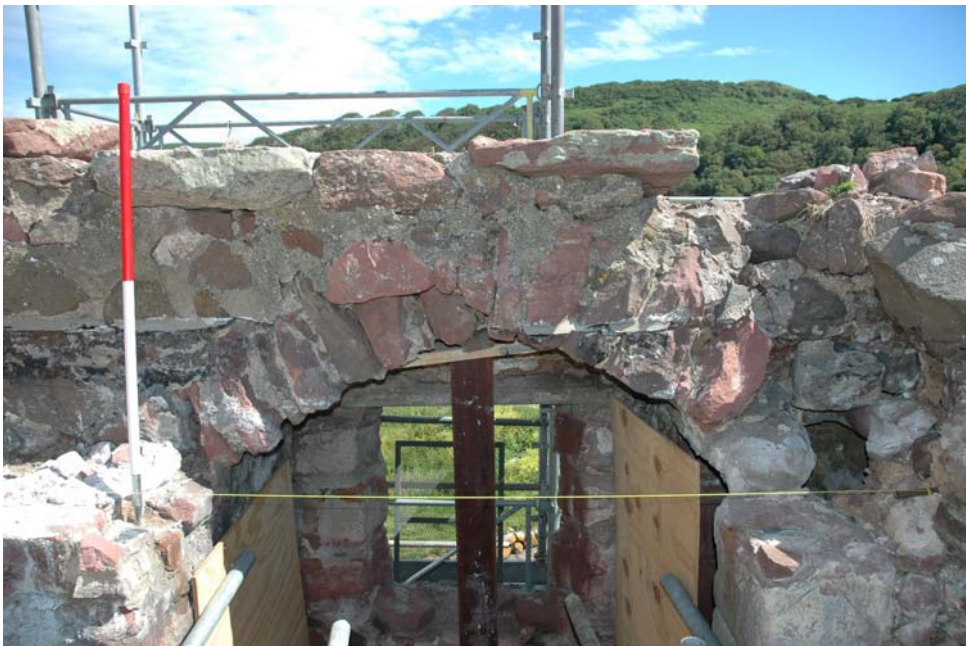
Plate 69:

Window W3-1 after the concrete roof removed. Note the cutting back of the wall.

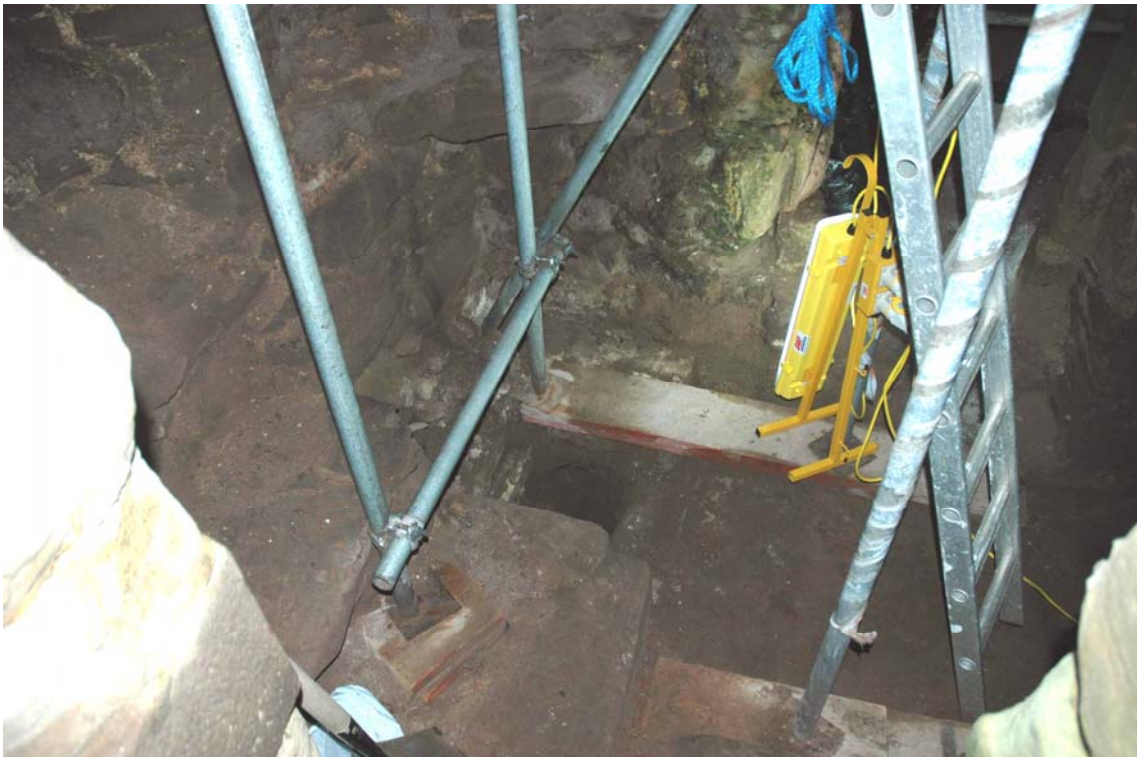
Plate 71:

Entrance to pit prison from the bottom of the spiral stair.
